## BURROWS PARK AMENITIES

### SITE ANALYSIS AND SPORTSFIELD MASTERPLAN

RANDWICK CITY COUNCIL

OCTOBER 2024

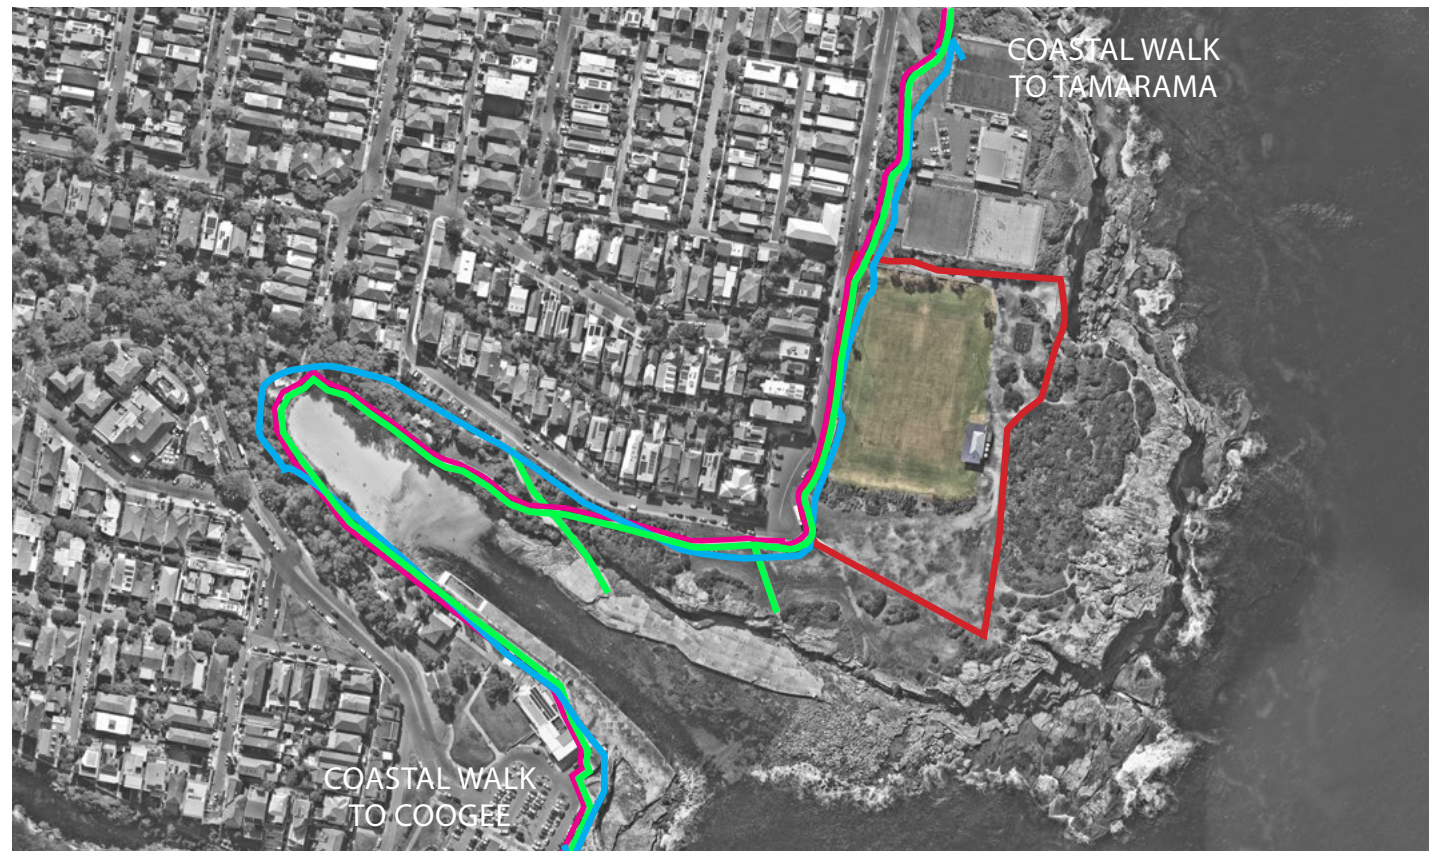
- There are currently approx. 16 parks with the use of a sports field within Randwick's LGA, including Burrows Park.
- There are 3 other Rugby Sportsfields within a 5km radius
- There are 5 other Rugby Sportsfields within a 10km radius
- Despite a generous proportion of parklands within the Randwick LGA, there are few that have the capability for sportsfields.

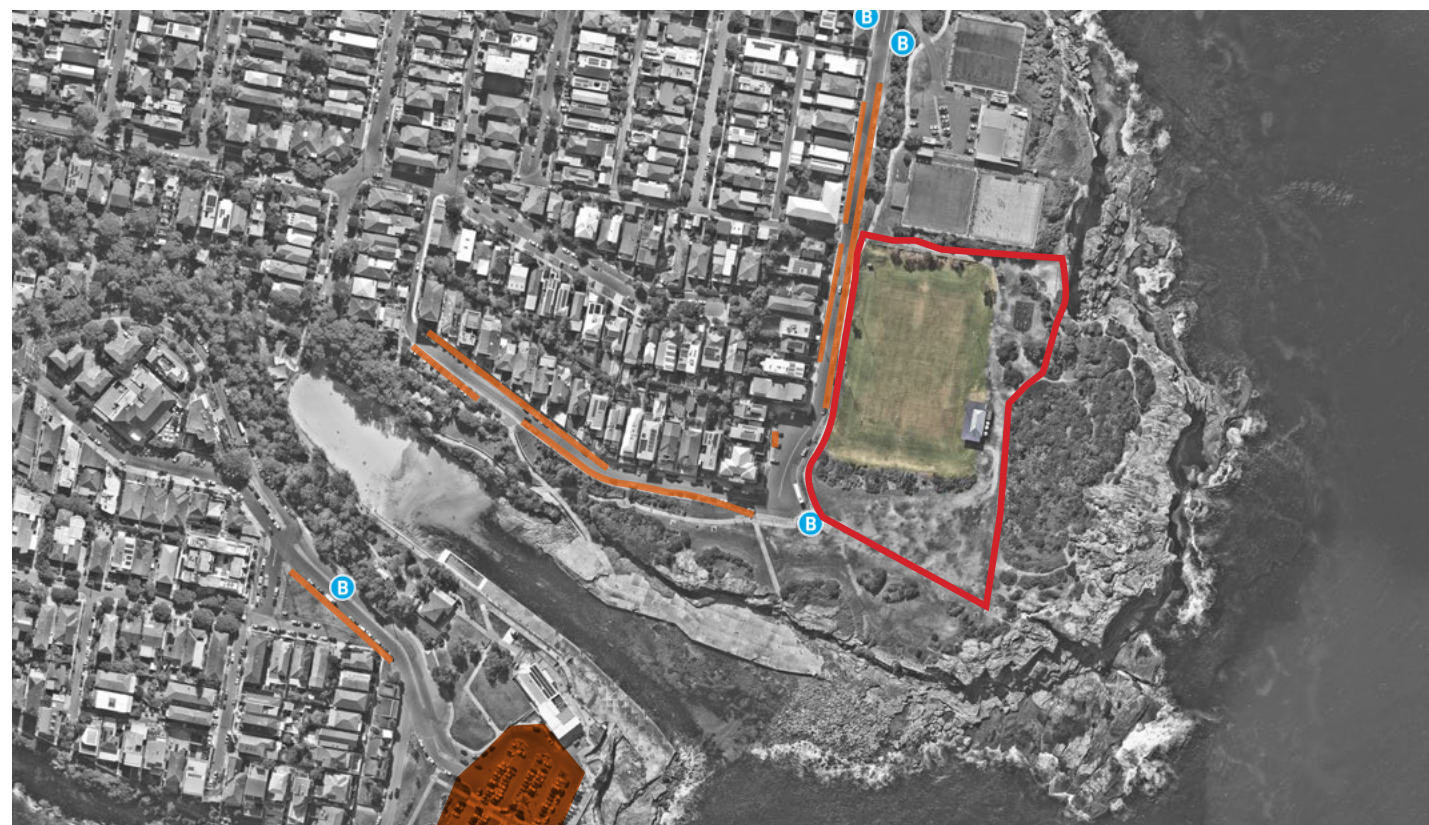
- The site forms a node to popular walking and cycling routes including Bondi to Coogee and forms a key link to Clovelly Bay
- The site is reasonably well serviced by public transport, with bus stops at the top and bottom of Ocean road
- There is vehicle parking along Eastbourne Avenue, Ocean Road and Boundary Street.

- VEHICLE PARKING
- B BUS STOP LOACTIONS
- SITE

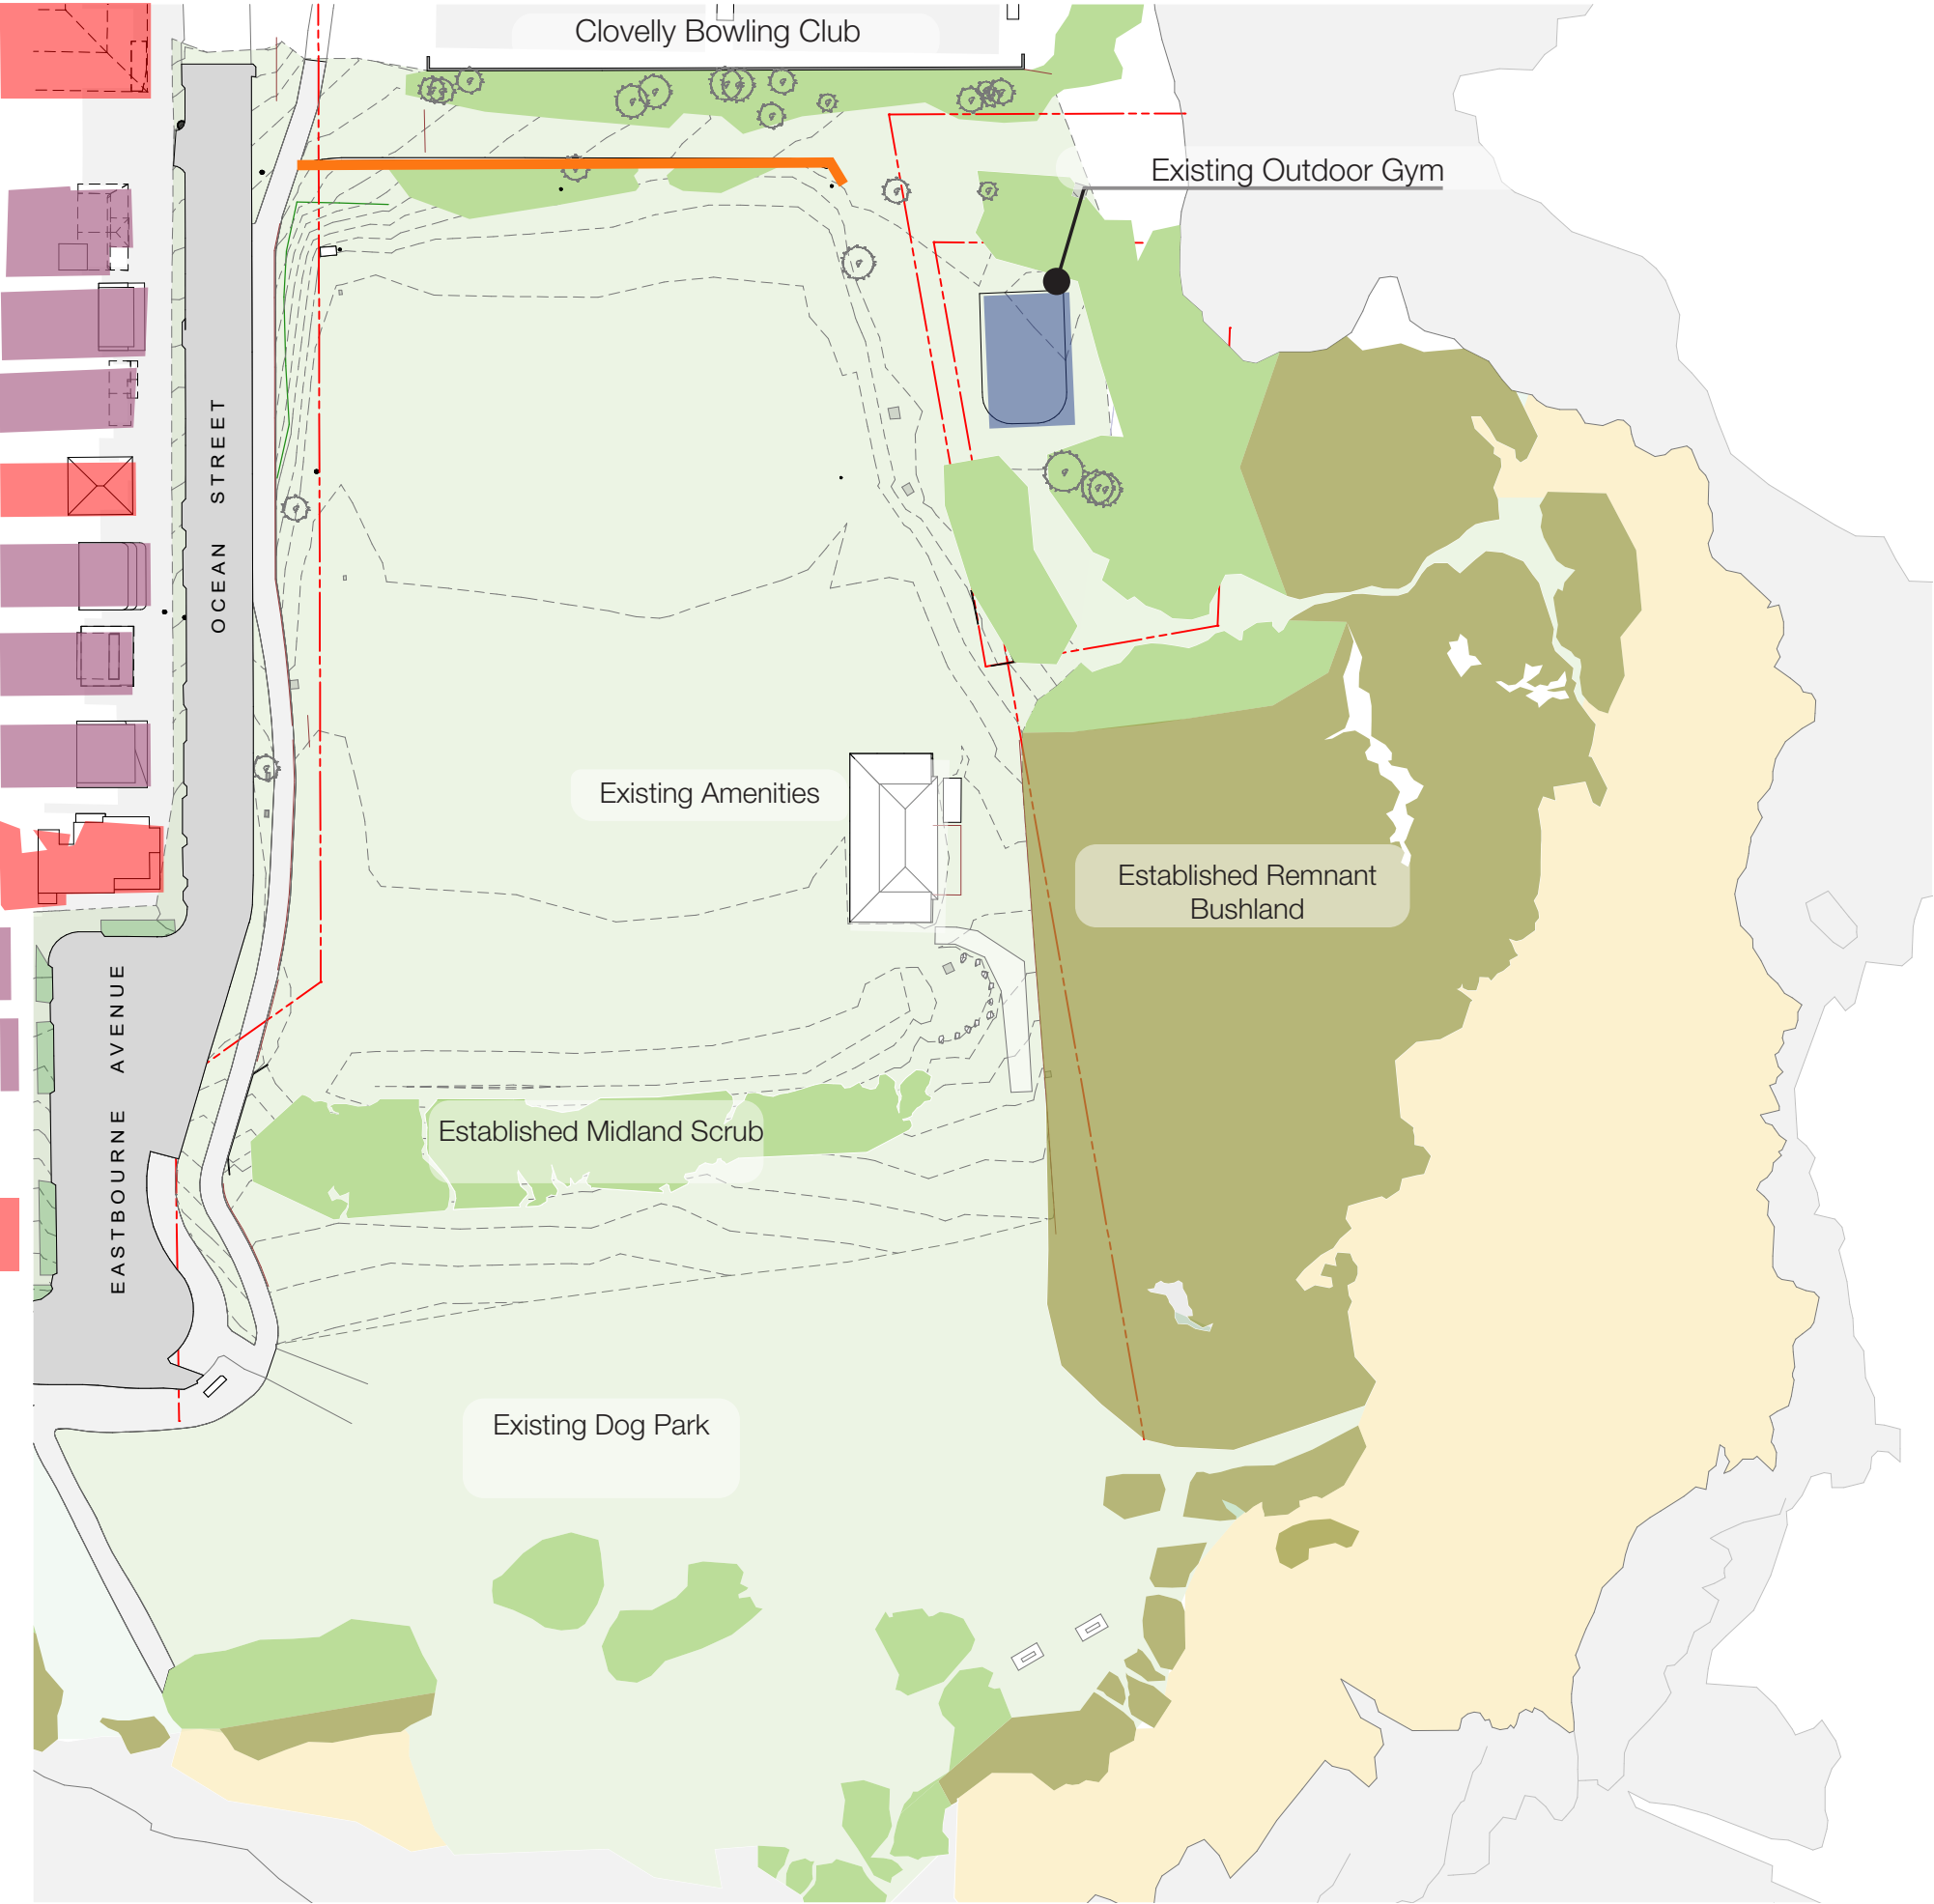
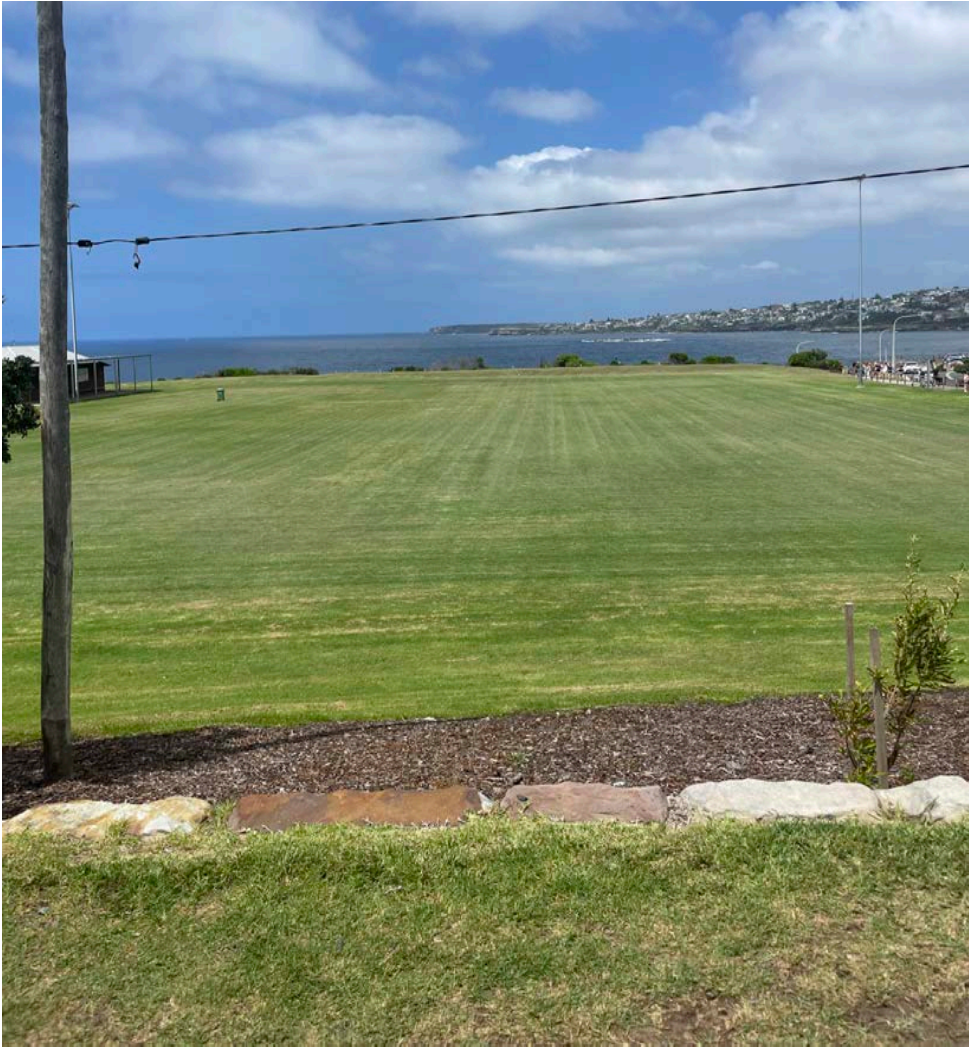
- Existing Retaining Wall
- Existing 1-3 Storey, Single Resi.
- Existing 3+ Storey, Multi Resi.
- Remnant Bushland
- Sandstone Cliffs considered part of Remnant Bushland
- Midland Scrub - Part of Existing Site Character

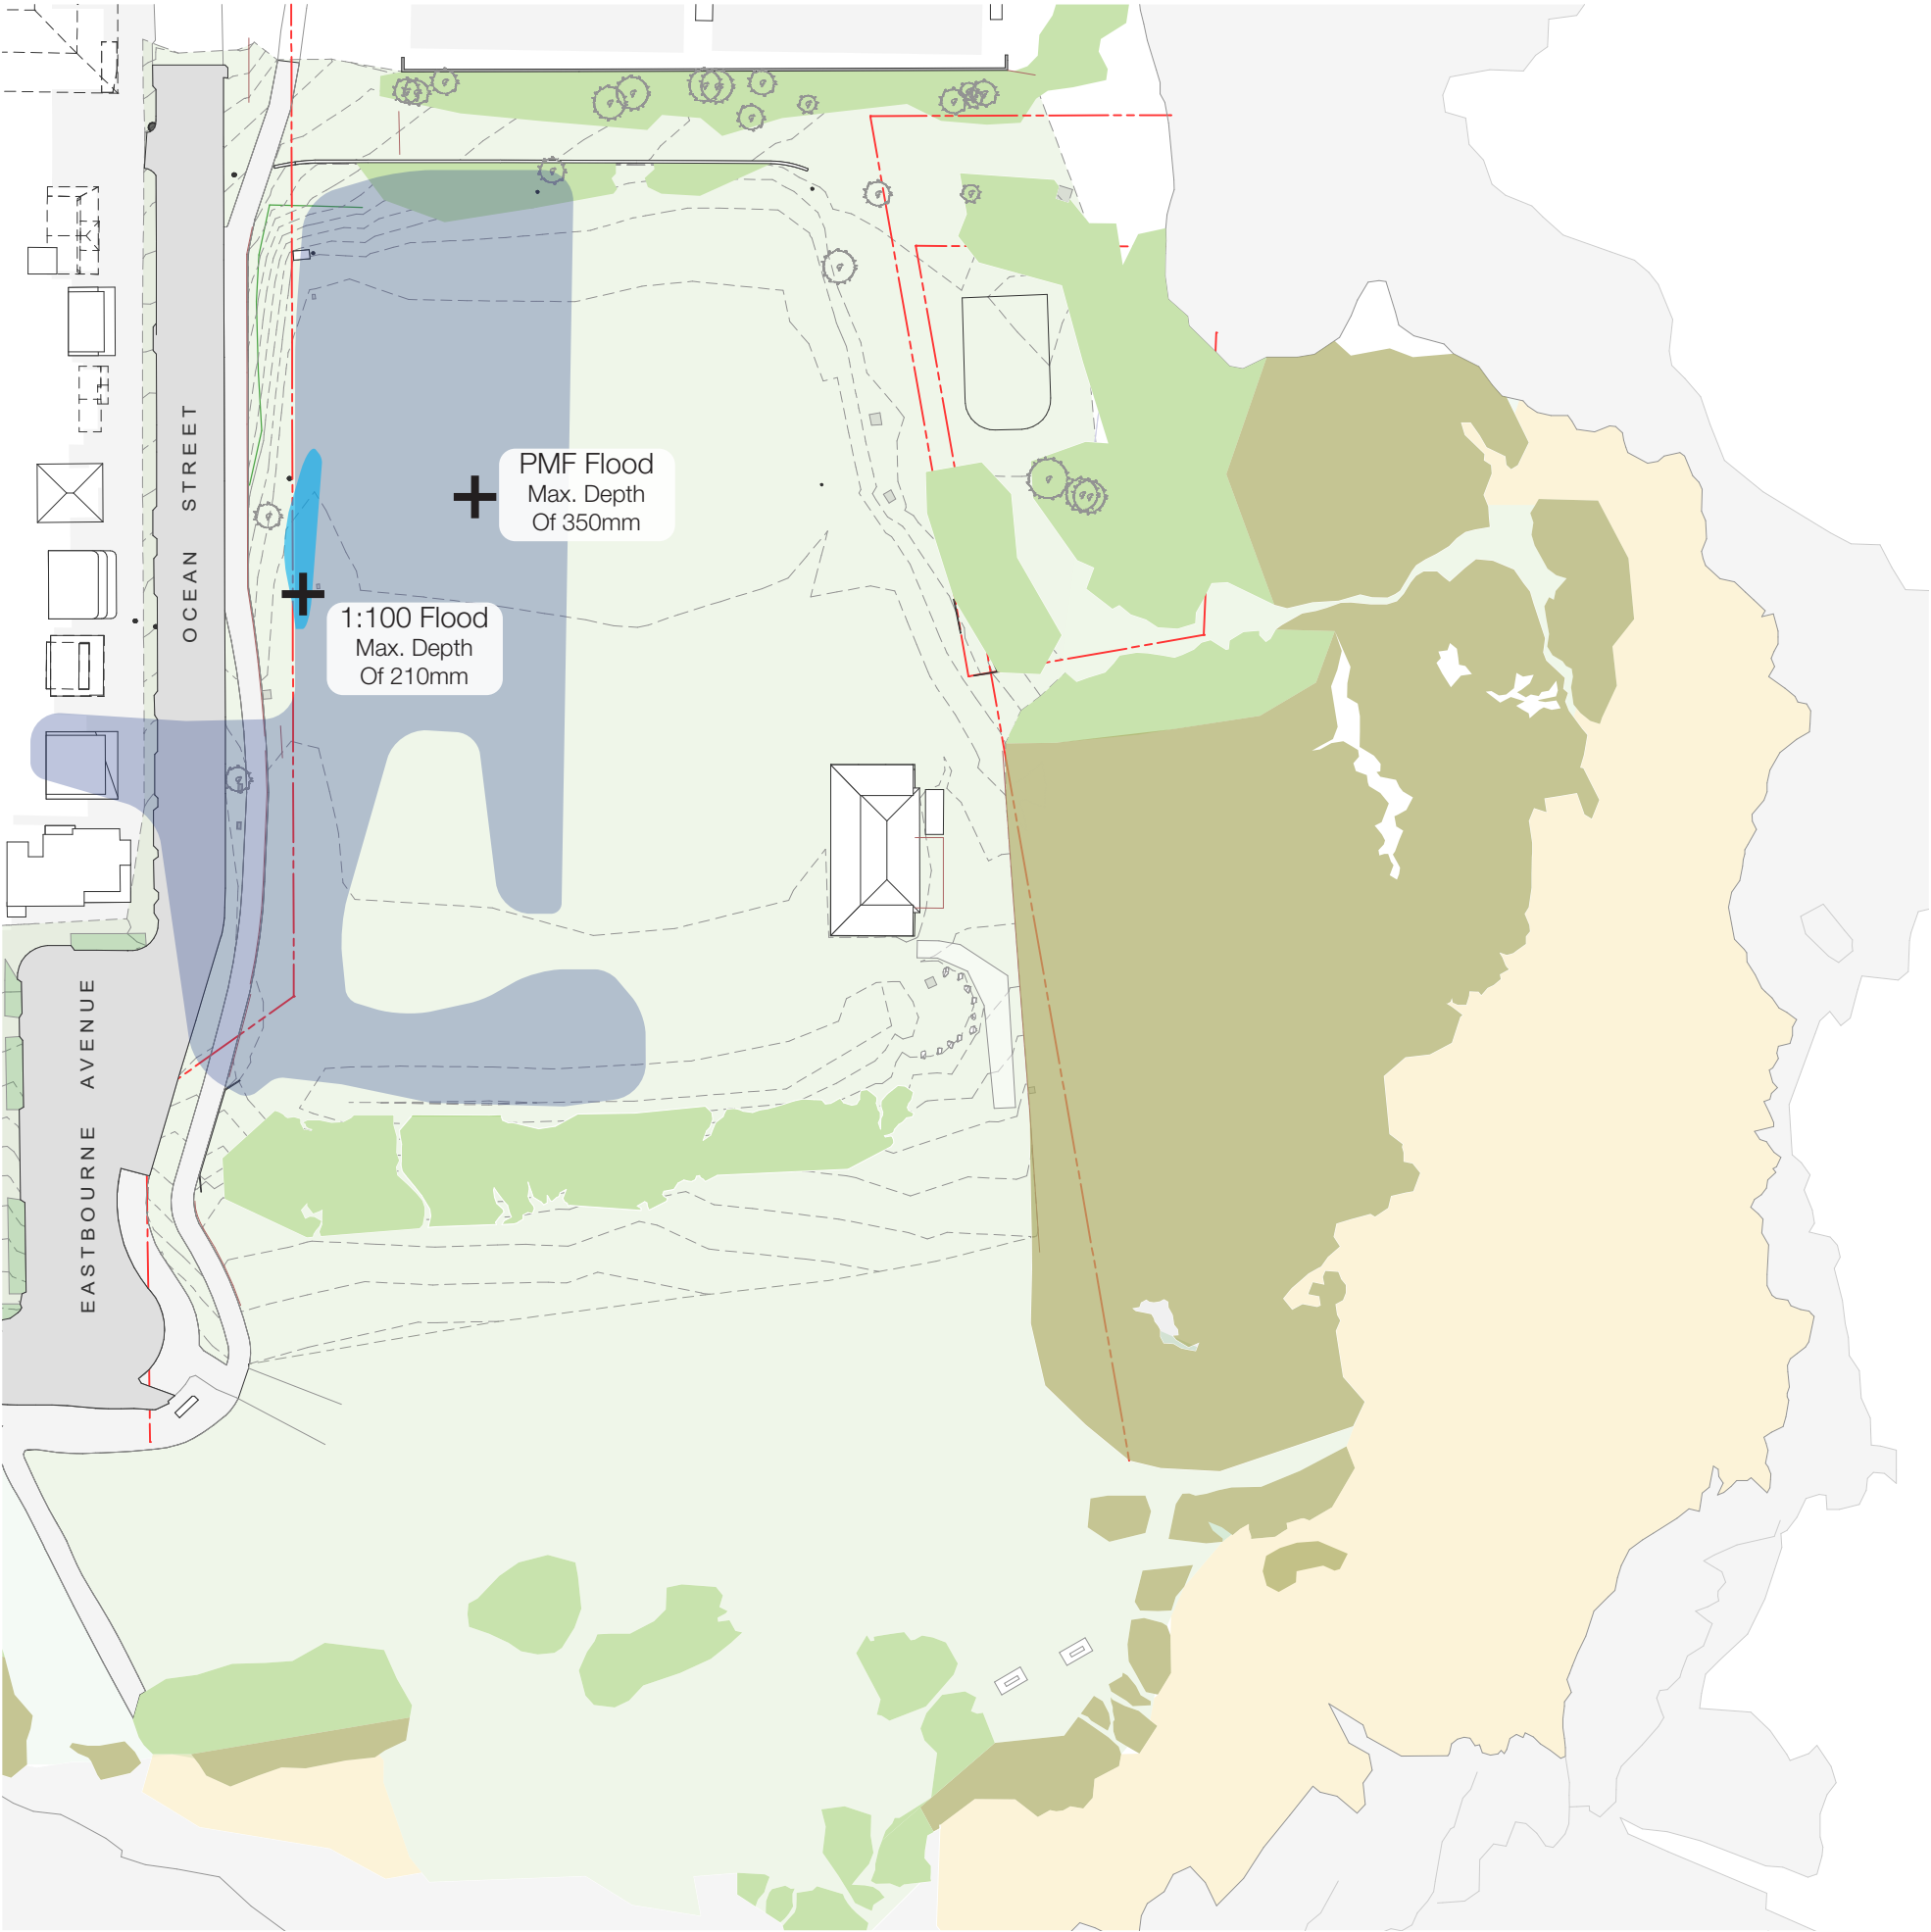
- Mapping provided by council shows that the eastern edge of the site is most impacted by flood events
- While it is noted that the PMF (Probable Maximum Flood) level occupies a large portion of the site, this event is typically theoretical and unlikely to actually occur.

- PMF (Probable Maximum Flood) Flood Event Extents
- 1% (1 in 100 year) Flood Event Extents

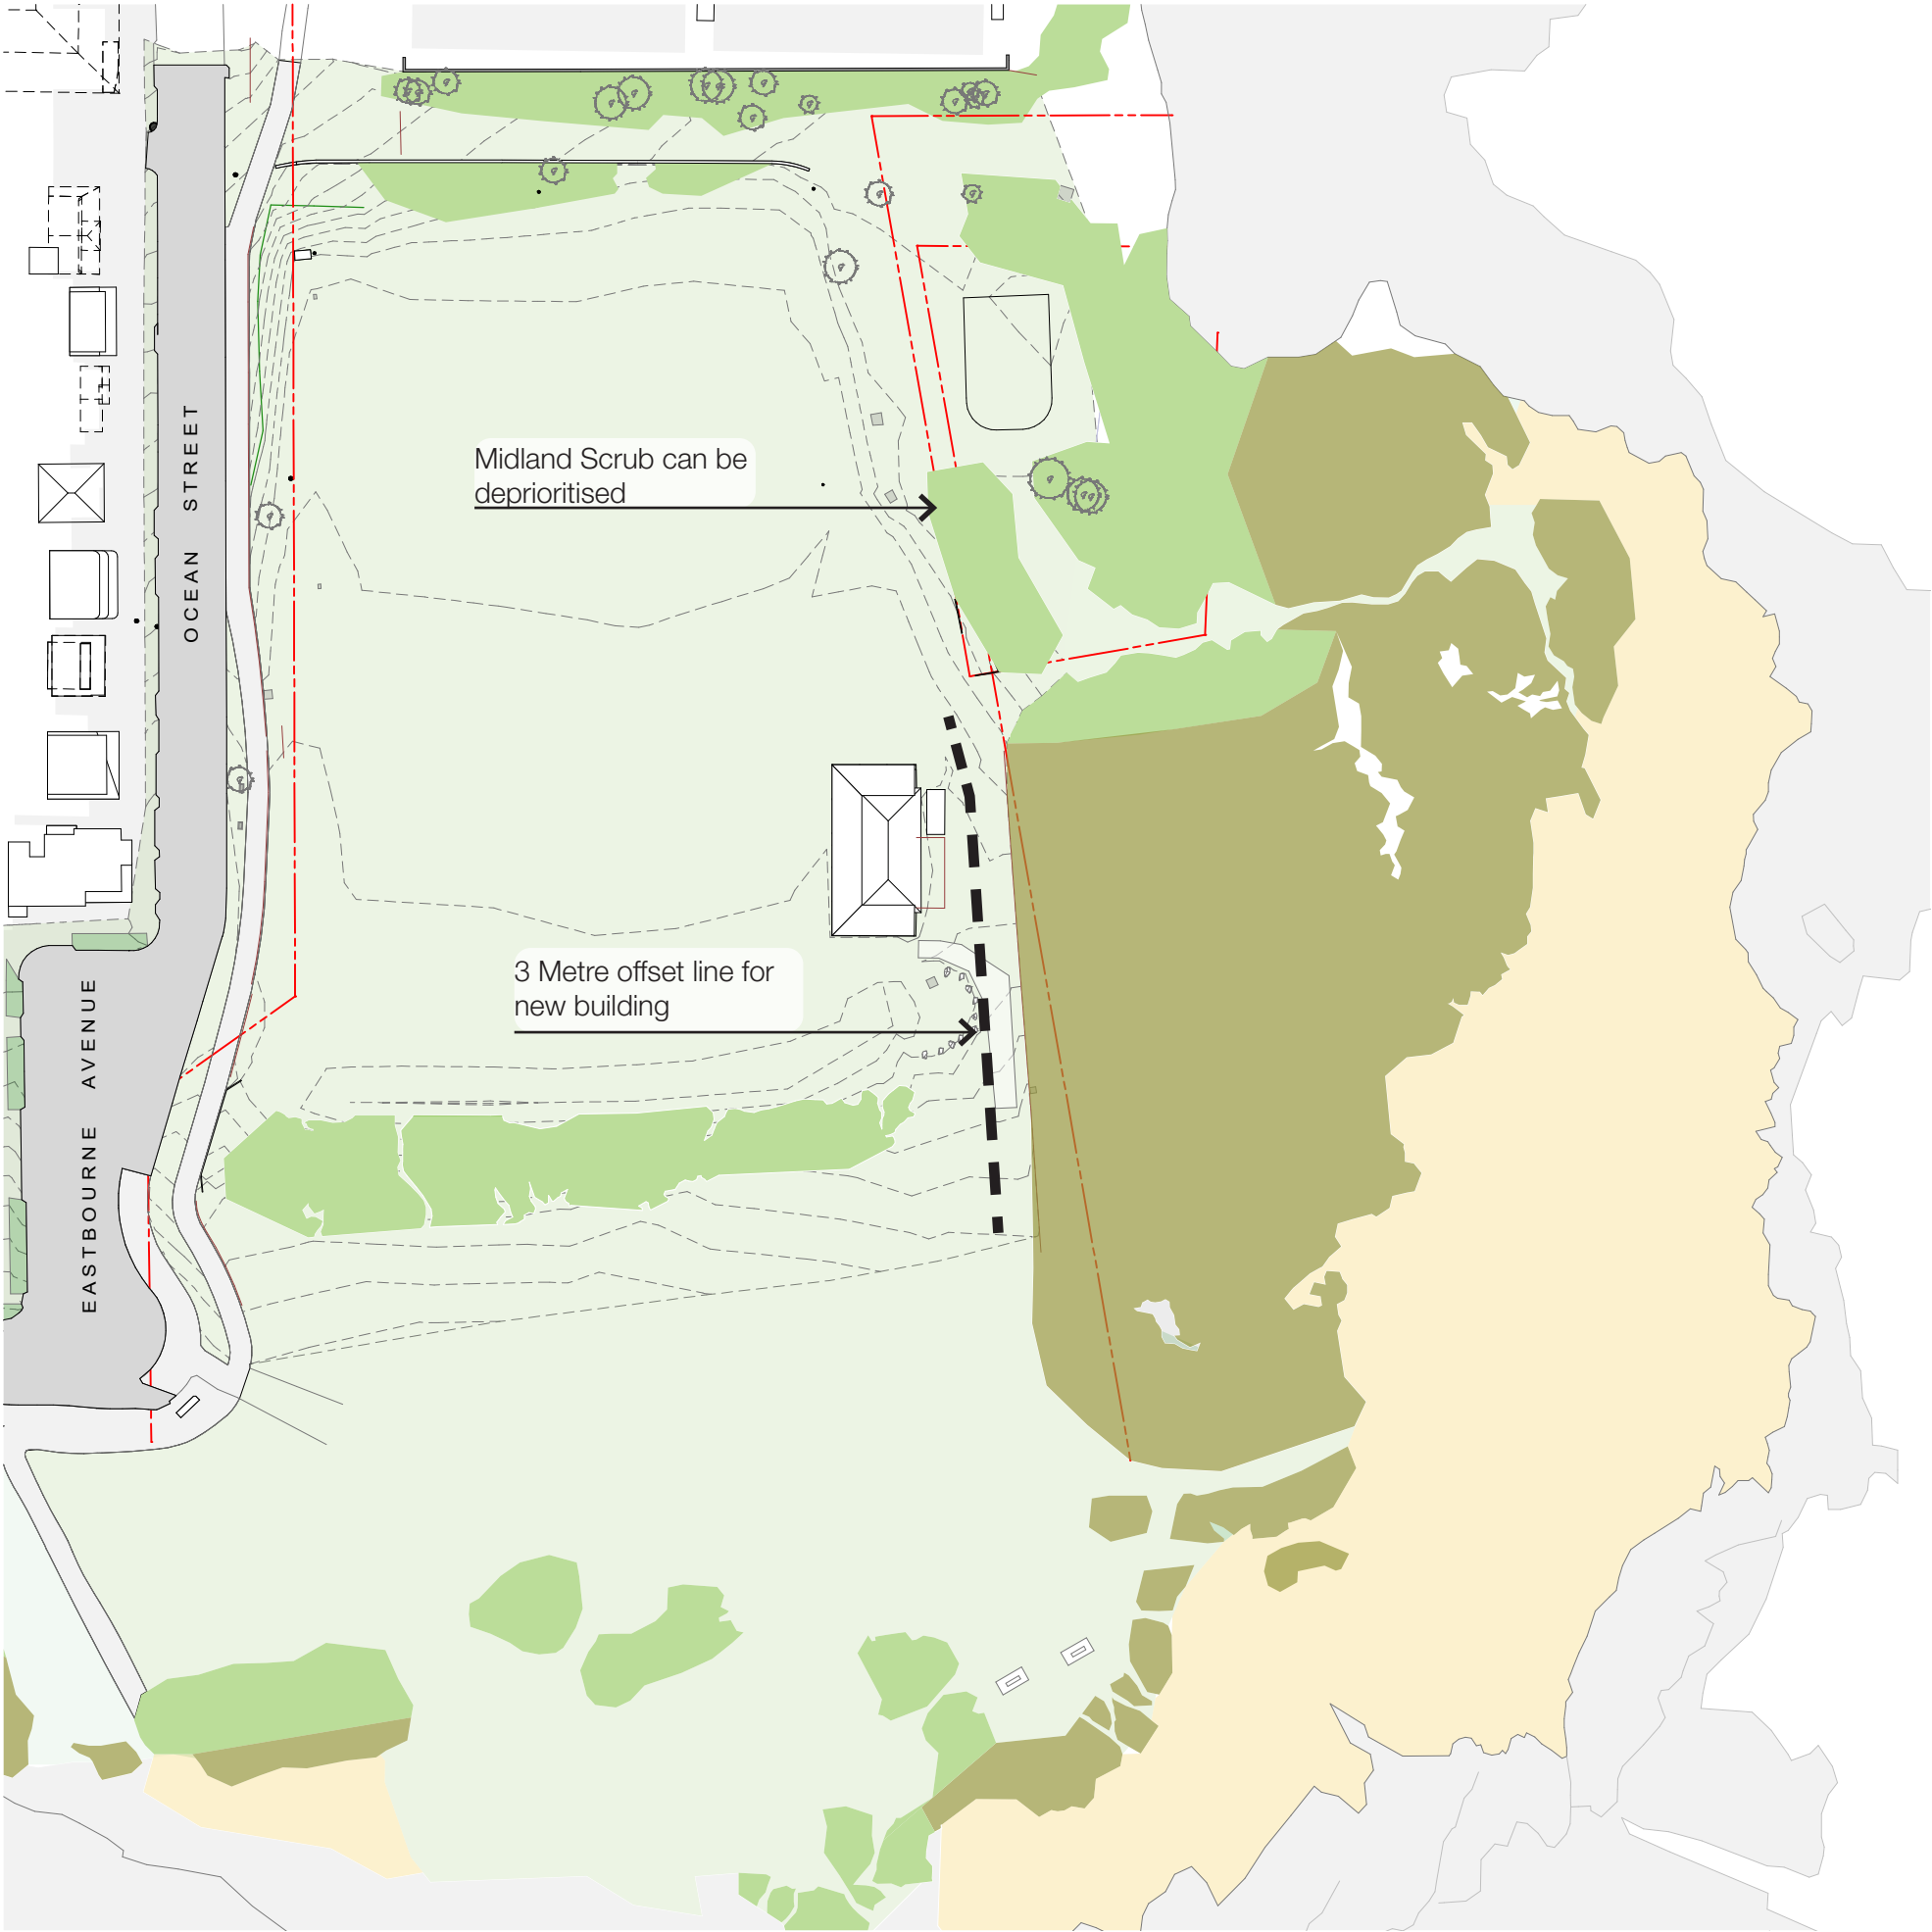
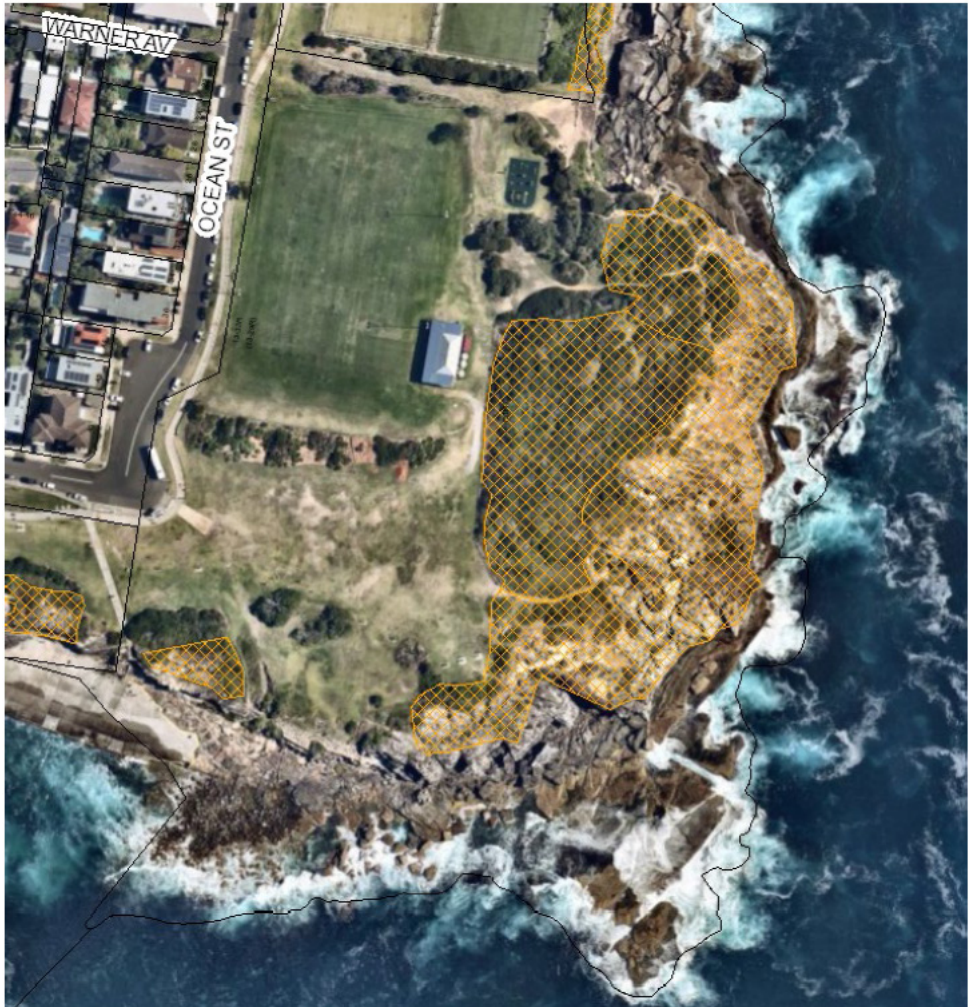
Image provided by Randwick City Council providing extents of Remnant Bushland

- New Building line offset from remnant bushland - 3 metre zone required for firefighting access and protection of root zones
- Remnant Bushland - Mid Height Shrubbery is a disappearing and increasingly rare asset, in removing these habitats we are losing birds species
- Sandstone Cliffs considered part of the remnant bushland
- Area not considered Remnant Bushland - this is however a great asset to the site, acting as a buffer between the two uses of sports field and dog park.

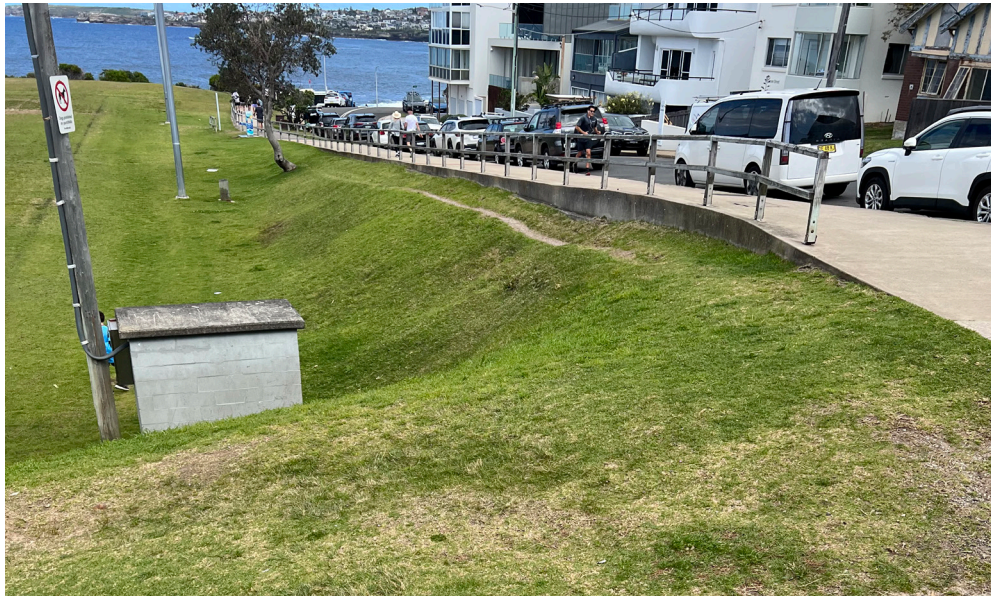
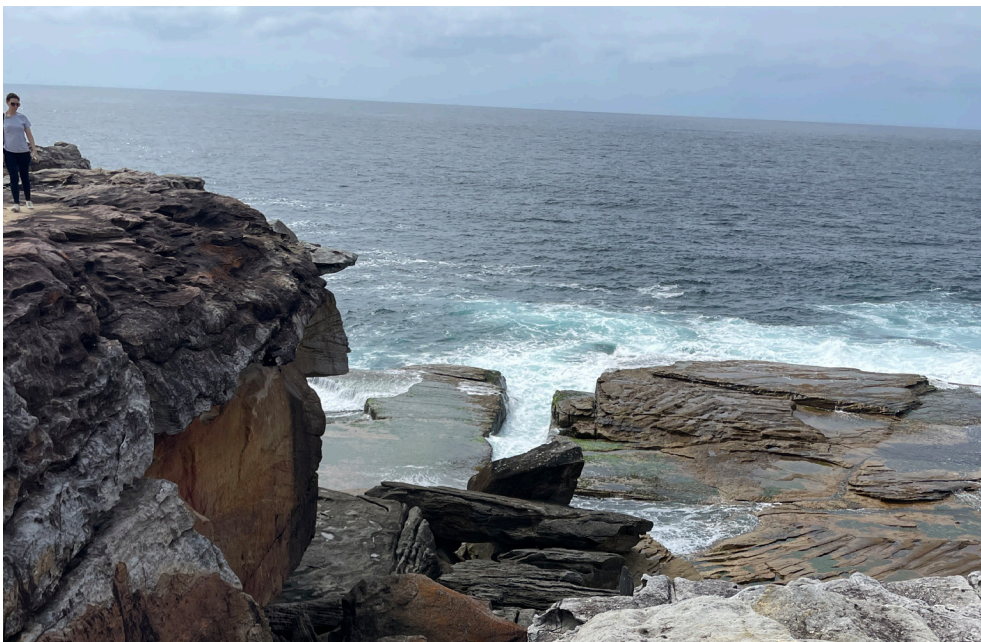
- The site and existing building lies at a midpoint between the high and low points of the reserve, and is partially sunken into the landscape.
- The existing building is 5 metres tall in total, and closely relates to the highest point of the site.

- ← Gradients Across Site
- Distinct Coastal Edge and layers of stratum

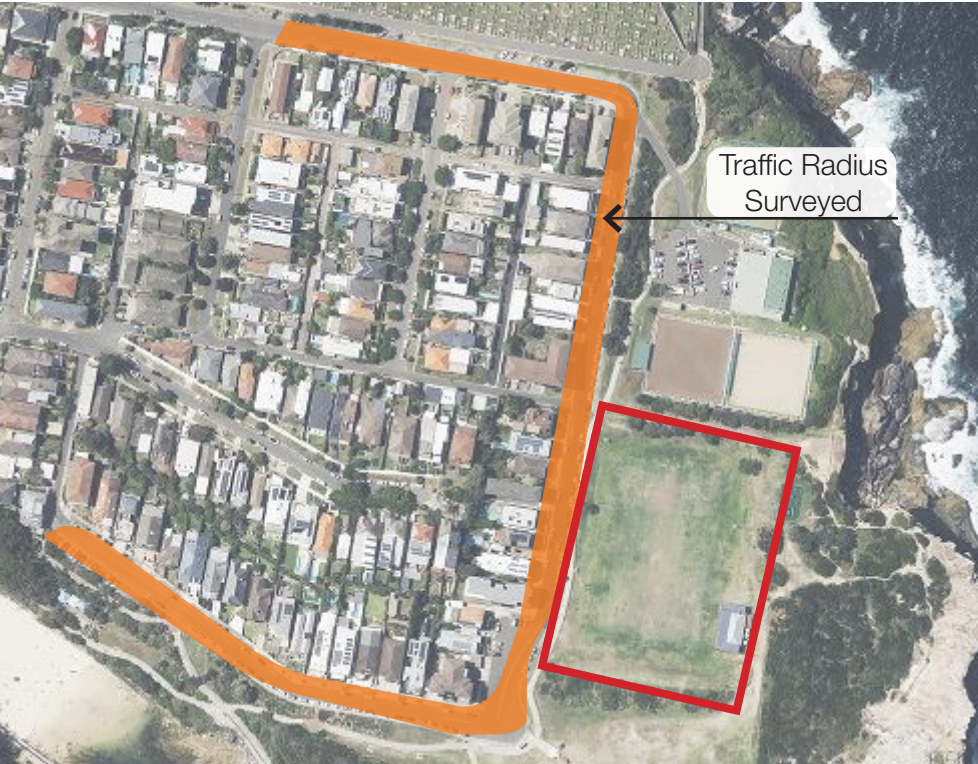
- Preliminary Traffic Report and surveying examined a 5 minute (400 metre) walking radius, encompassing Ocean St, Eastbourne Ave and Boundary St, with approx. 189 car spaces within this radius.

- At various times of the year, there is an occupancy rate of between 42% and 91% for these spaces, with occupancy typically lower in the winter months in which rugby league games are played.

- The typical amount of available parking spaces on Saturdays (85) is sufficient to accomodate the estimated parking demand (70 spaces) when games are being played, and could be additionally moderated by staggering game times at 15 minute intervals.

Existing Emergency Vehicle access

Bus Zone

No Stopping

Approx. 75 car spaces

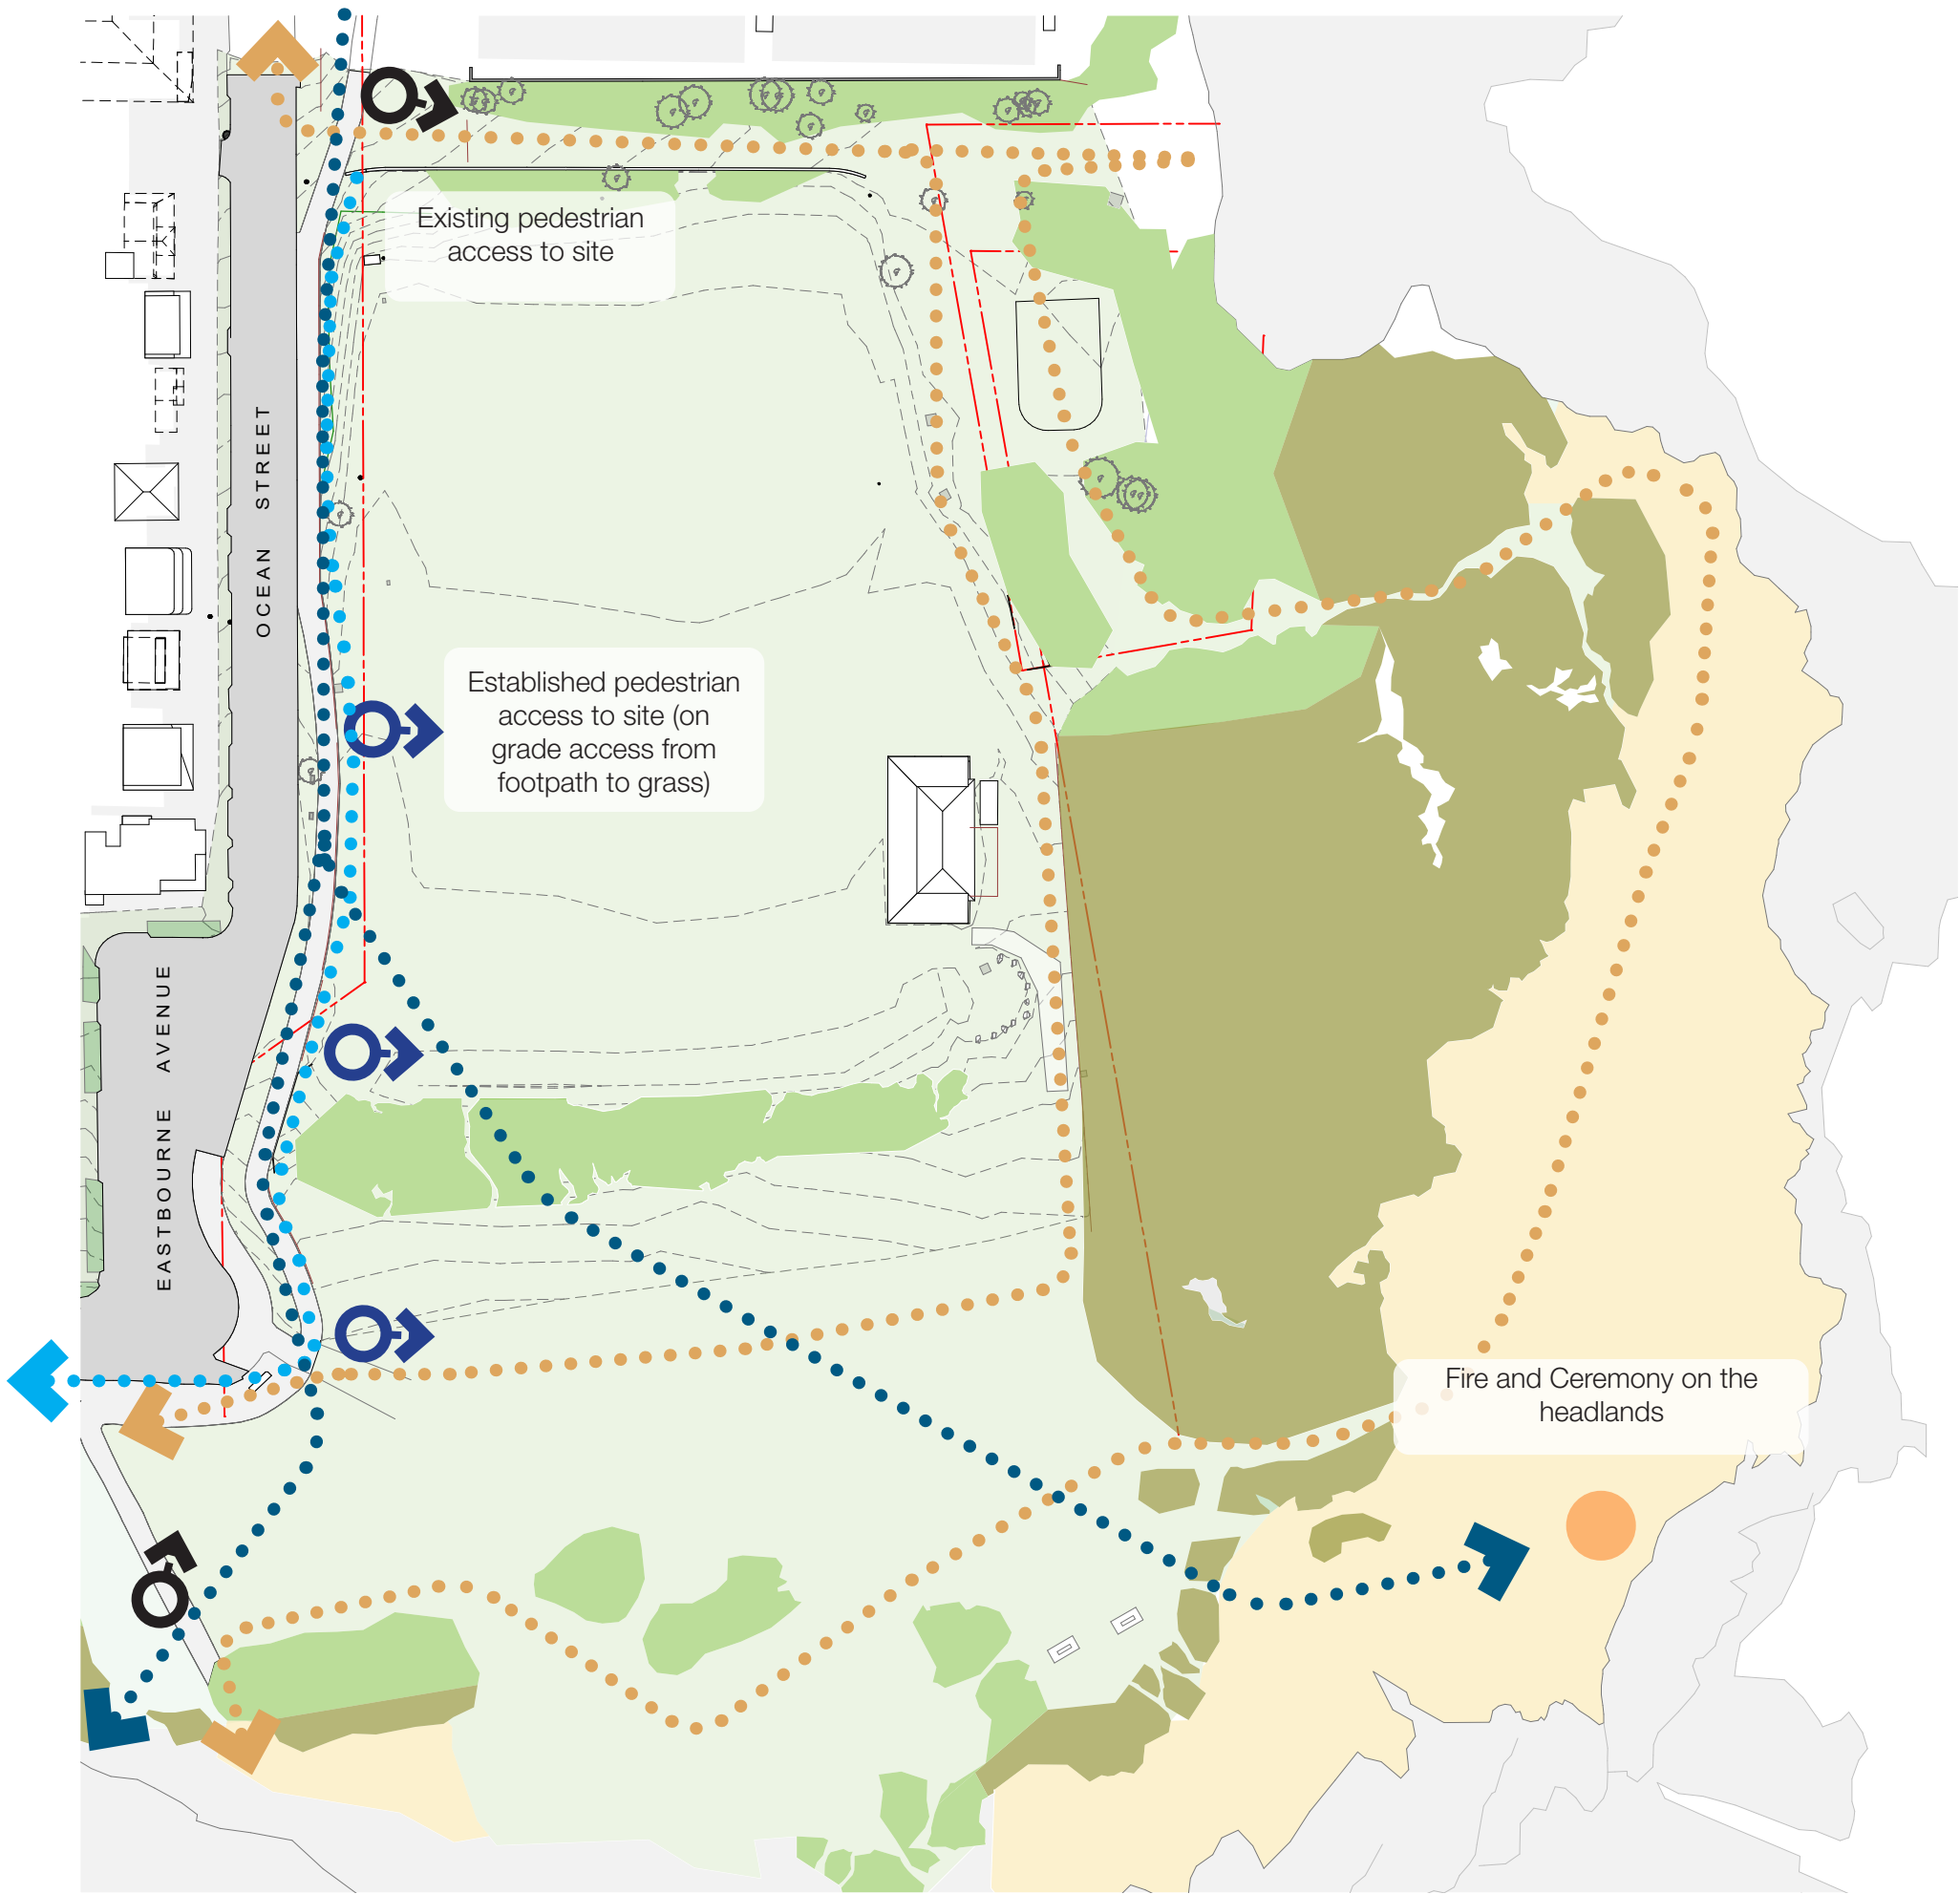
- The site is accessed via the existing footpath along Ocean Street and Eastbourne Avenue, as well as via stairs from Clovelly Bay
- The site acts as a through link to the cliffs to the east via the established paths through the remnant bushland.
- Whilst the footpath along Ocean Street is the main route for the Bondi to Coogee Walk, the remnant bushland and cliffs are often used as an informal detour
- Currently, there is an informal link between the dog park and Burrows Park Sportsfield at a grade of approximately 1:15.
