## BURROWS PARK AMENITIES

### SITE ANALYSIS AND SPORTSFIELD MASTERPLAN

RANDWICK CITY COUNCIL

OCTOBER 2024

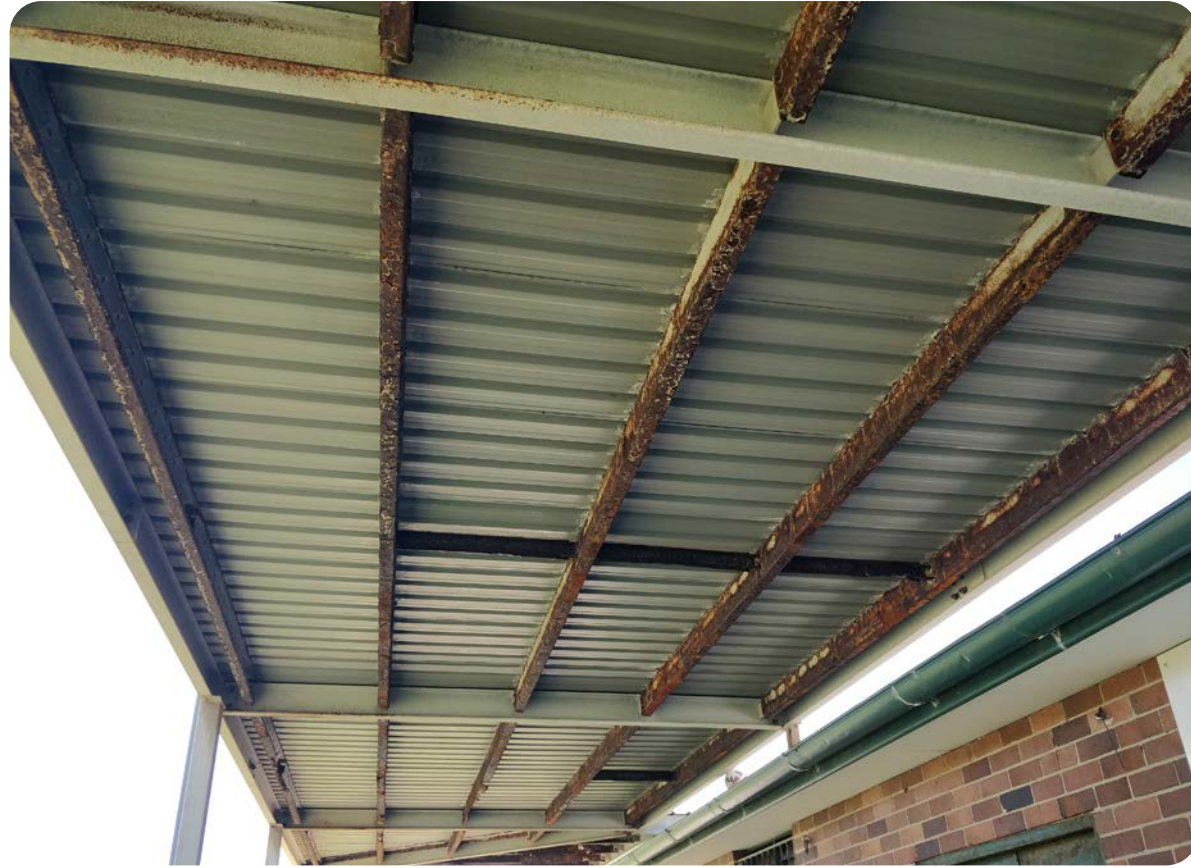
- Existing building is generally in poor condition - it is likely that rooms do not meet National Construction Code requirements for natural light and in some instances ventilation as well.
- Bligh Tanner have undertaken a desktop visual assessment of the existing building both internally and externally, and have identified multiple cracks within the brickwork
- The existing awning purlins in particular have advanced rusting and weathering - it is noted within the structural report that it may be unsafe under high winds
- If the building were to be retained and adapted for new program, it would likely require significant structural work including wall demolition, new lintels for roof support and potentially new or adapted roof framing.
